600,000 Gallon Mountain Road Storage Tank Condition Assessment Report

Village of Irvington, NY

Date
October 19, 2009

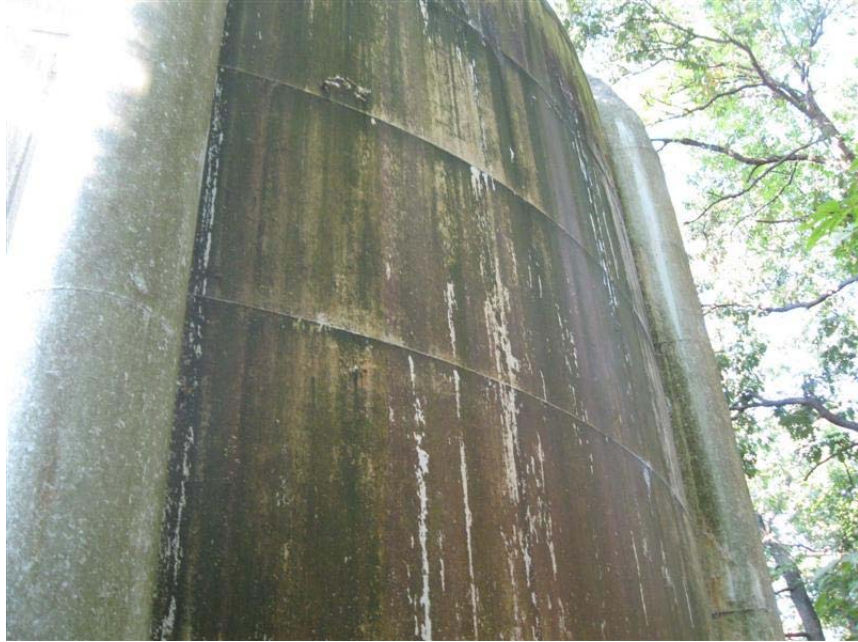
The exterior coating system is in very poor condition. The exterior coating system is exhibiting areas of corrosion, mildew, chalking, and delamination of the finish coat. The appearance of the coating system is poor with areas of mildew, chalking and oxidation. There are localized areas of heavy rust on the decorative pilasters, sidewalls and roof of the tank.

The dry film thickness on the exterior shell is between 5.8 and 11.7 mils. The adhesion of the exterior coatings is poor and not suitable for overcoating. There is evidence of lead based paint or primer under the urethane coating. (See photos # 1 - 4).

Photo #1 Mildew staining, corrosion, chalking, and coating failure on sidewalls.

- **Within the next year, the exterior coating system should be properly prepared by sandblasting to a SSPC #6 Standard and coated with a 3 coat urethane system to prevent permanent damage to the tank and any further loss of metal.**
- **Additionally, the decorative pilasters should be removed due to the severe corrosion in several areas. Relocation of the inlet pipe may be necessary once the pilasters are removed.**
- **Due to the age and poor condition of the tank it is recommended that the Village evaluate the cost of repairing the tank against the cost of constructing a new tank on this site.**

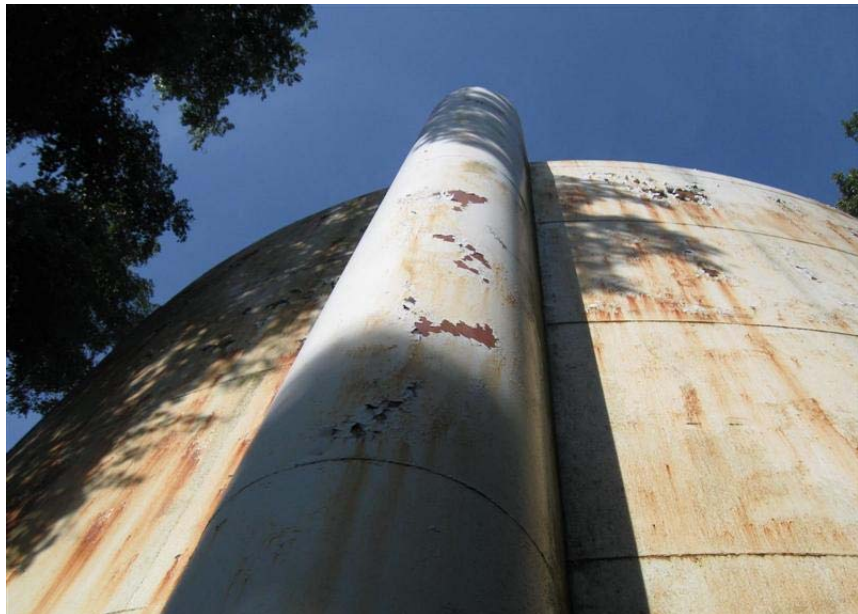
Photo #2 Corrosion, mildew staining and overall coating failure on sidewall.

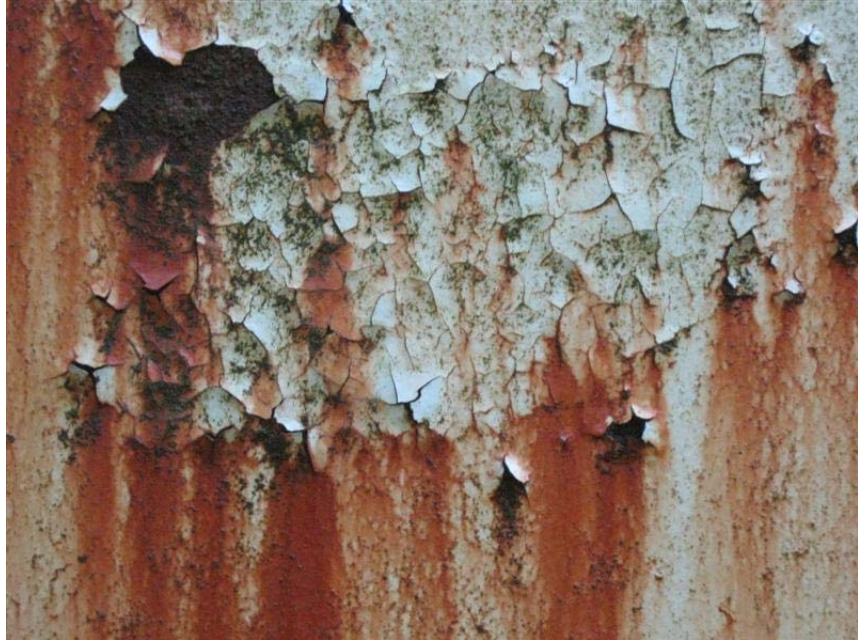
Photo #3 Corrosion and delamination. Overall the exterior coatings are in very poor condition.

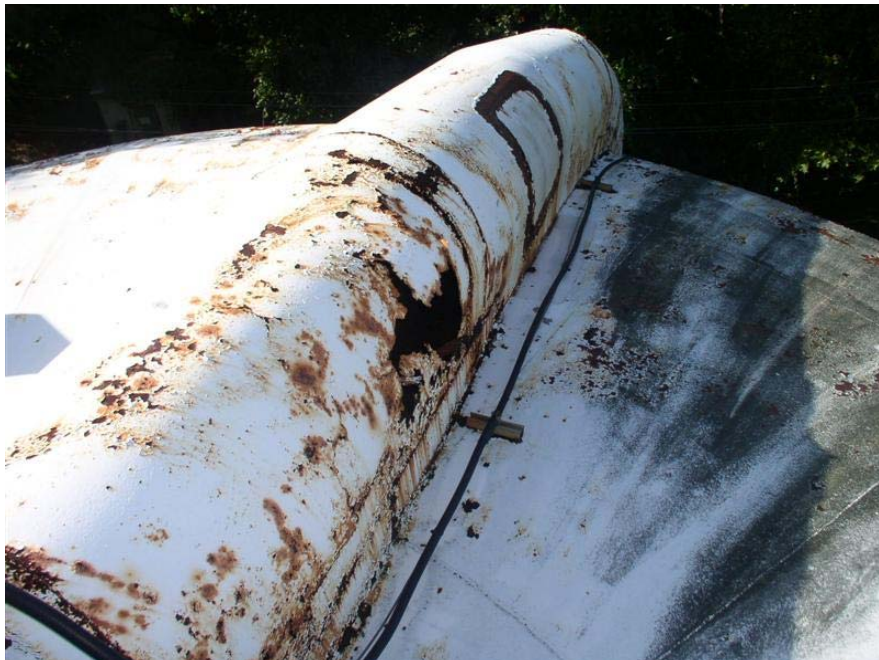
Photo #4 Severe corrosion on pilasters. It is recommended to remove the pilasters.

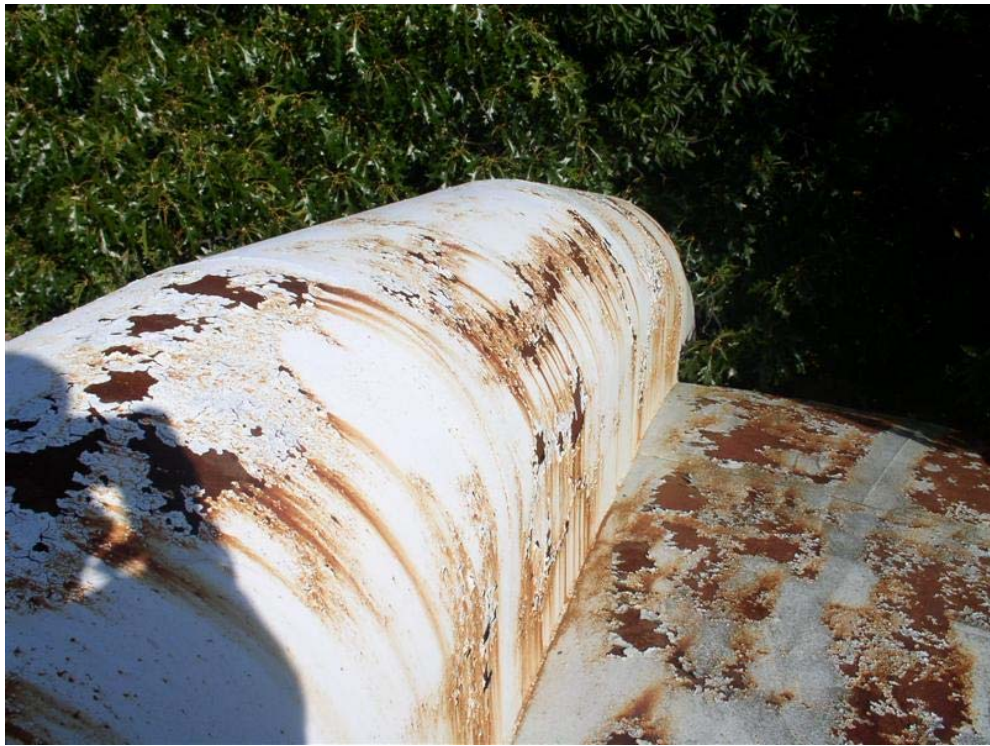
The roof coatings are in very poor condition. The coating is thinning and heavy corrosion is apparent on approximately 15 to 20% of the surface area. (See photos # 5 - 8).

Photo #5 Coating failure on roof.

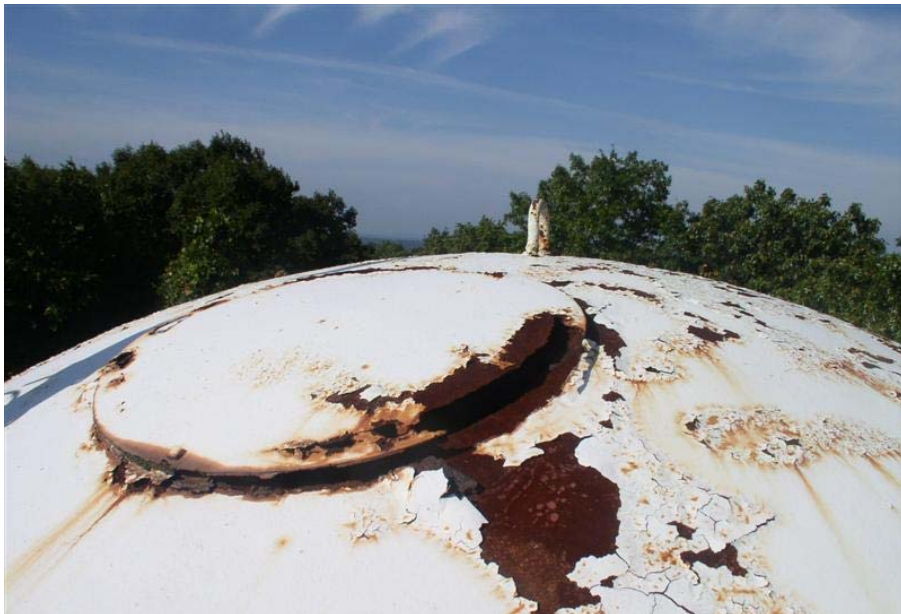
The top of the cupola is severely corroded and has a large open area where the steel has completely rusted away. This is sanitary hazard. (See photo #6)

Photo #6 Coating failure, severe corrosion, and metal loss on roof cupola. Opening at top is a sanitary concern where birds, bugs and other vermin could enter the tank.

It is recommended install new roof vent to cover the existing opening in the cupola.

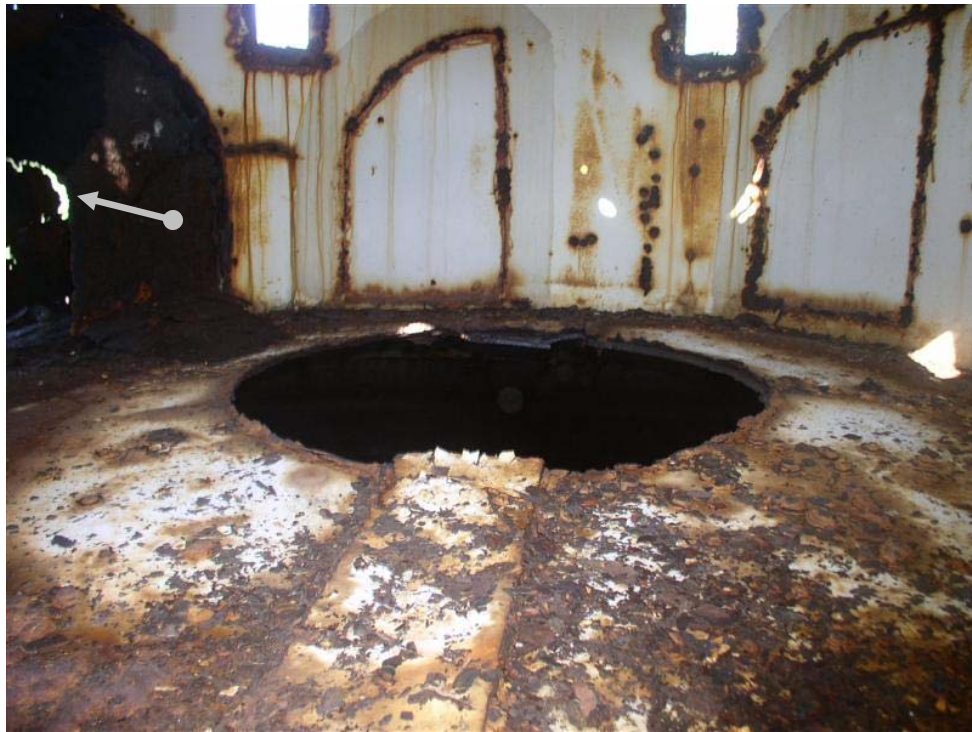
Photo #7

Severe corrosion on roof inside cupola. Holes in pilasters provide openings for birds, bugs and other vermin to enter the tank opening. (arrow)

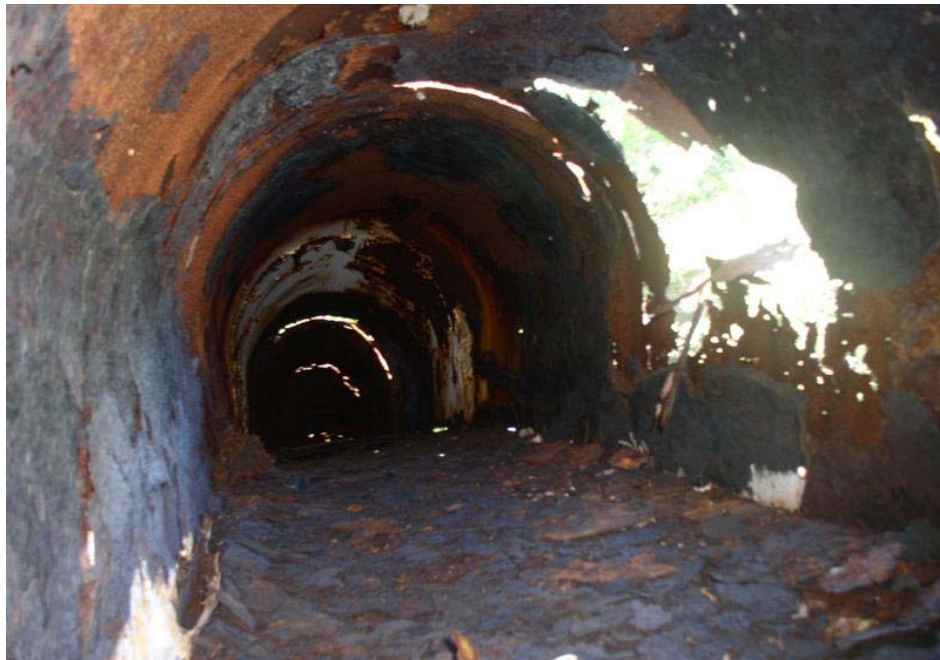
Photo #8

Sever corrosion on pilaster.

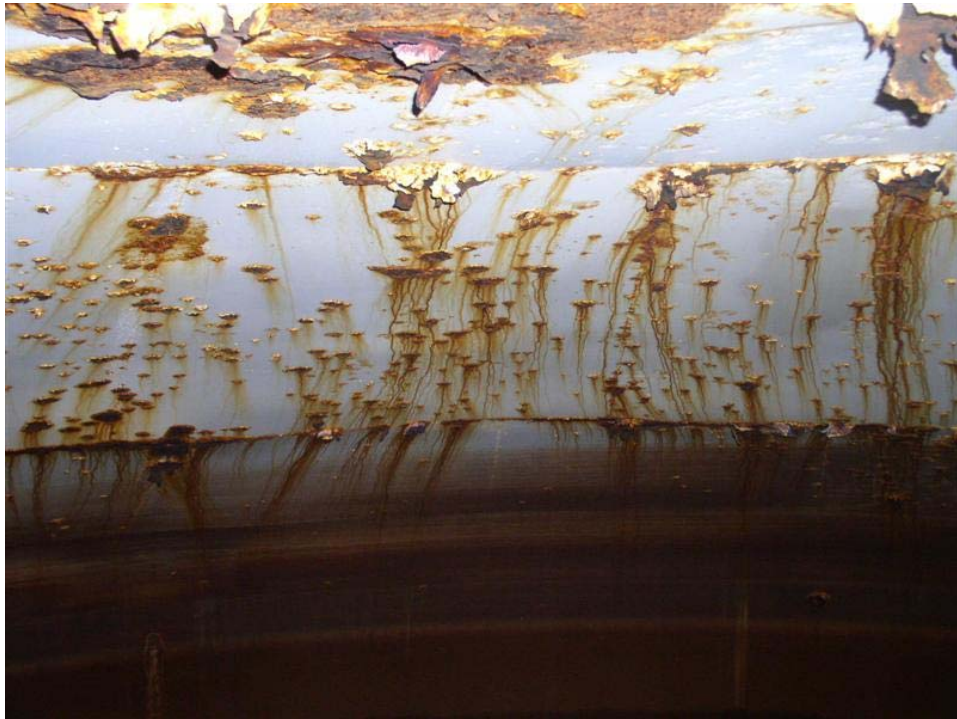
The interior epoxy coating system is in poor condition. There is evidence of moderate to severe corrosion above the high water level on the roof panels. There is one area of significant corrosion near the inlet pipe. (See photos # 9 - 11)

Photo #9 Severe corrosion on roof panels of tank interior.

- In order to protect the structural integrity of the tank for the long term, within the next year it is recommended that the interior of the tank be completely renovated by removing the existing lining by sandblasting to an SSPC #10 Standard, and relining with a new 3 coat epoxy system. The coating systems are failing and the corrosion on the roof panels and walls must be addressed.

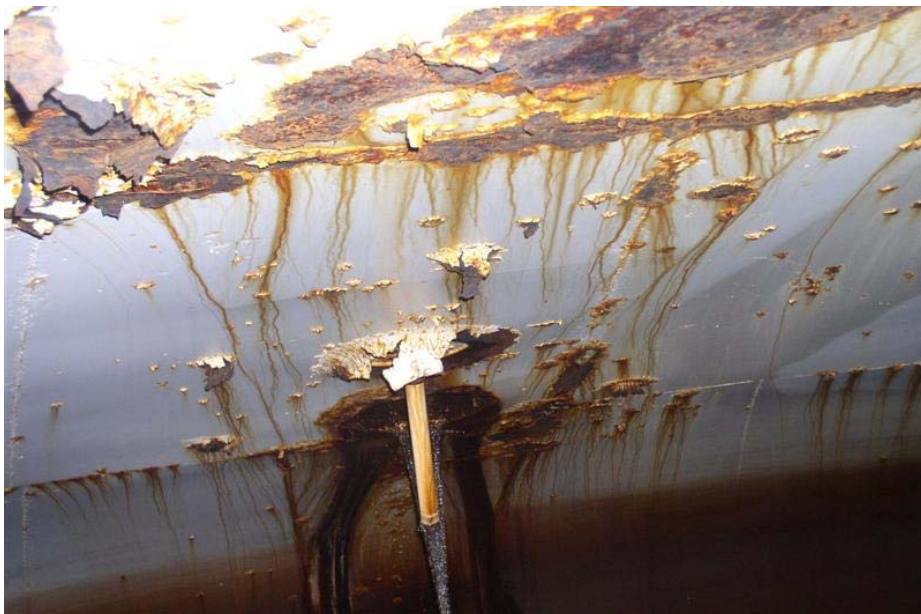
Photo #10 Corrosion on roof around fill pipe and chlorine tube.

- Relocate the inlet pipe and chlorine tube to enter the tank through the lower tier sidewall.
- Install and active mixing system to provide homogeneous temperature and disinfectant residual stability

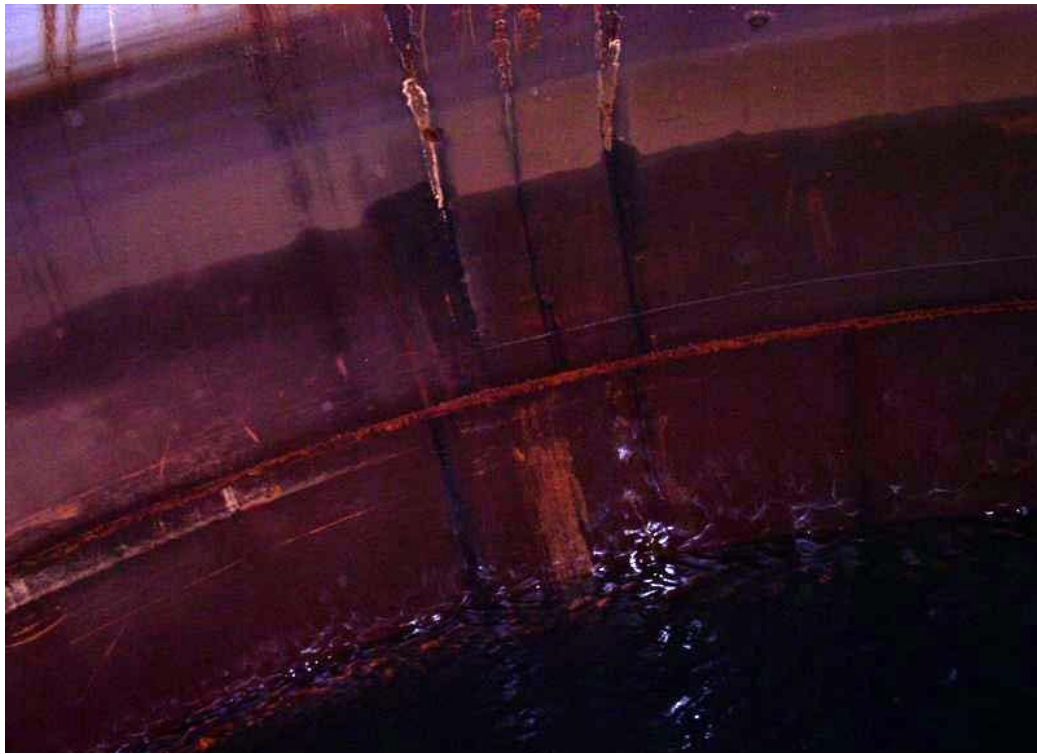
Photo #11 Tank sidewalls have active corrosion and heavy organic staining.

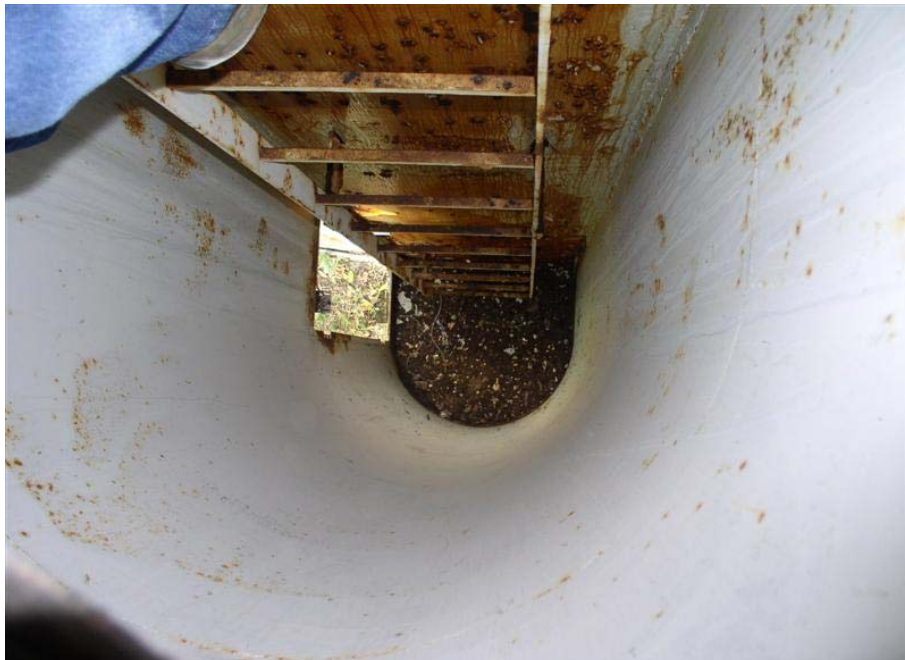
The exterior ladder is located on the interior of one of the decorative pilasters and does not comply with OSHA guidelines. The ladder does not contain a suitable cable style safety climbing device. (See photos # 12 & 13.)

Photo #12 Access ladder is in fair condition and does not have a suitable safety climb system.

After the external pilasters are removed, it is recommended to install a functional ladder gate on the exterior ladder.

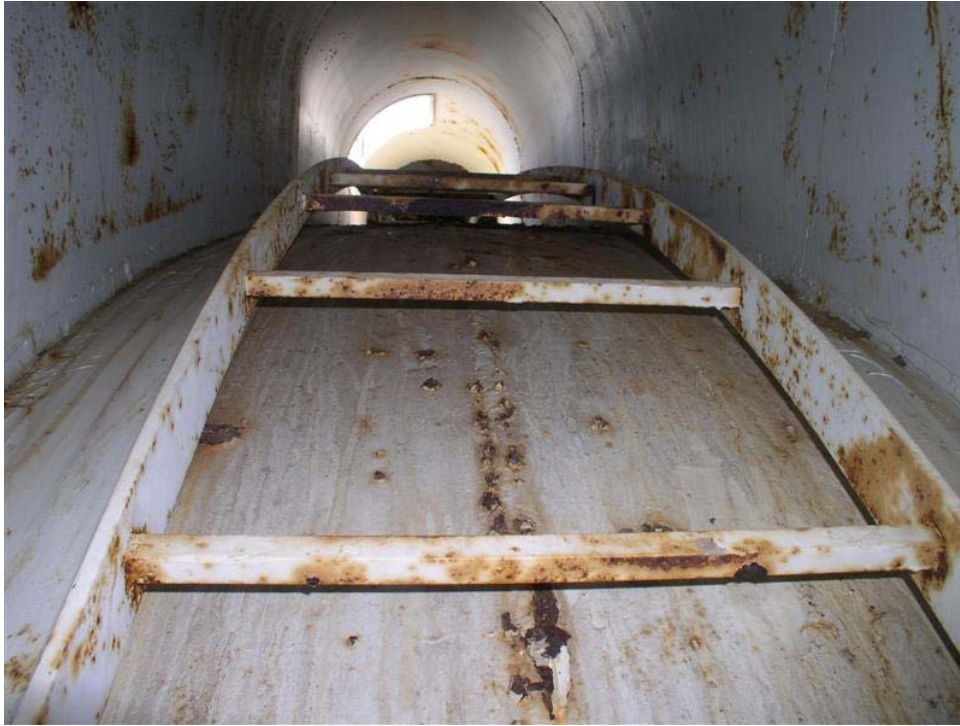
Photo #13 Dome roof ladder is in fair condition.

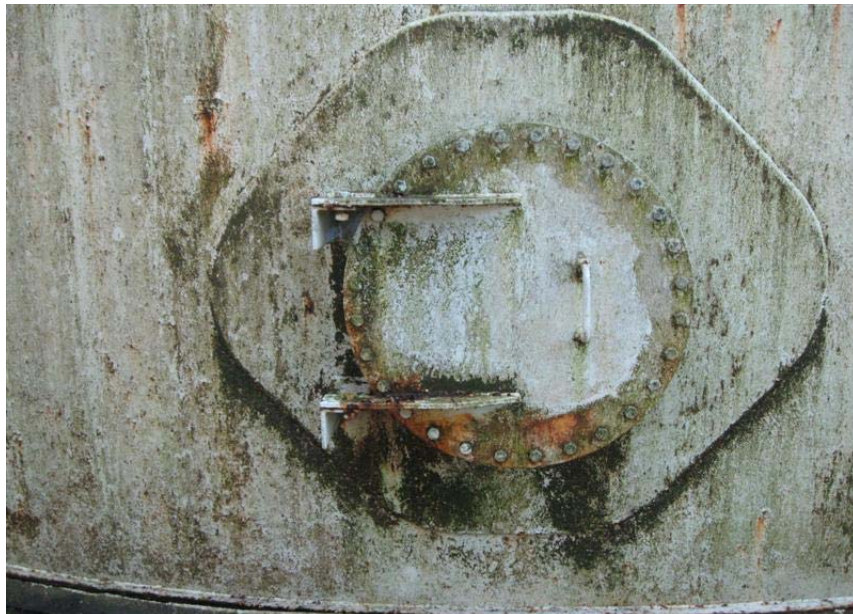
Photo #14 Shell manway complies with current standards and is in fair condition.

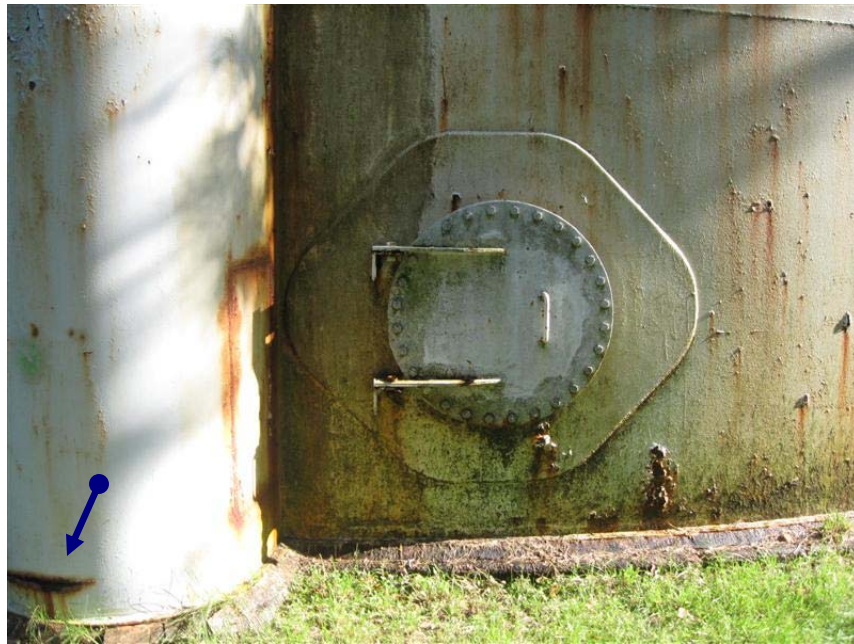
Photo #15 Secondary bolted shell manway. Note severe corrosion on base of pilaster.

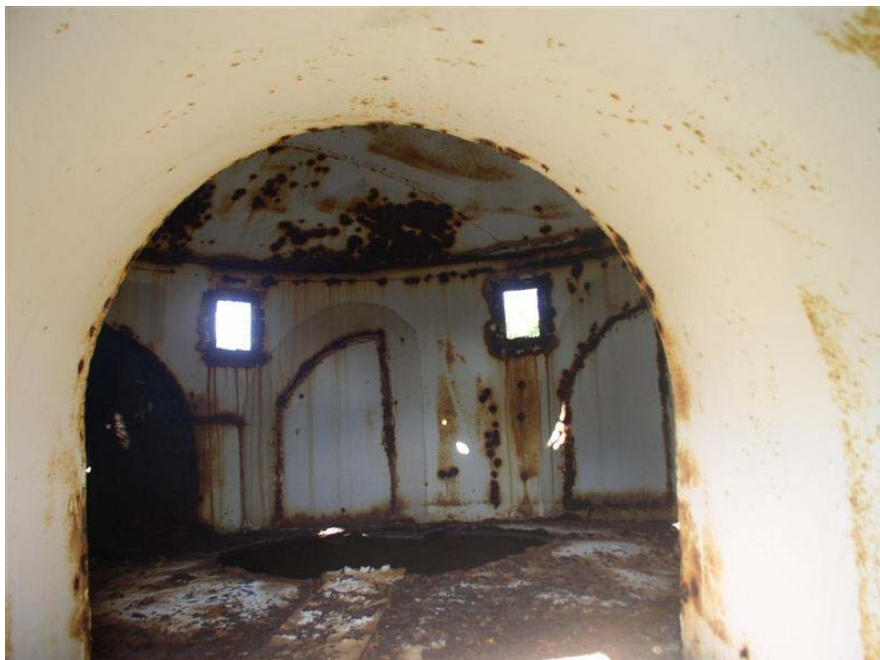
Photo #16 Secondary roof opening is the vent/cupola.

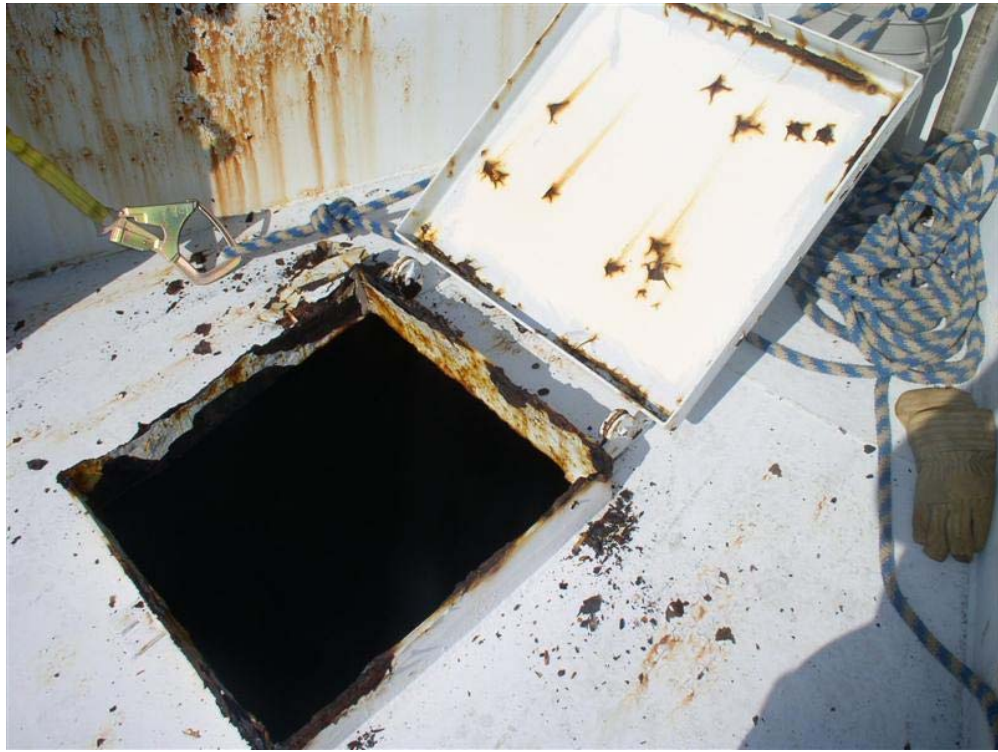
The roof hatch is 24-inches square and meets OSHA and AWWA guidelines which require that roof hatches be framed 4" to 6" above the surface of the roof at the opening and that it should be fitted with a solid watertight cover which overlaps the framed opening and extends down around the frame a minimum of two inches to prevent contaminated rainwater from entering the tank. There is severe corrosion on the hatch curb and on the underside of the hatch cover. The roof hatch was closed, but unlocked at the time of our inspection. (See photos #17 & 18)

Photo #17 Primary roof hatch that complies with current standards, but curb and cover are in poor condition and should be replaced.

It is recommended to replace the hatch curb and cover and lock roof hatch cover.

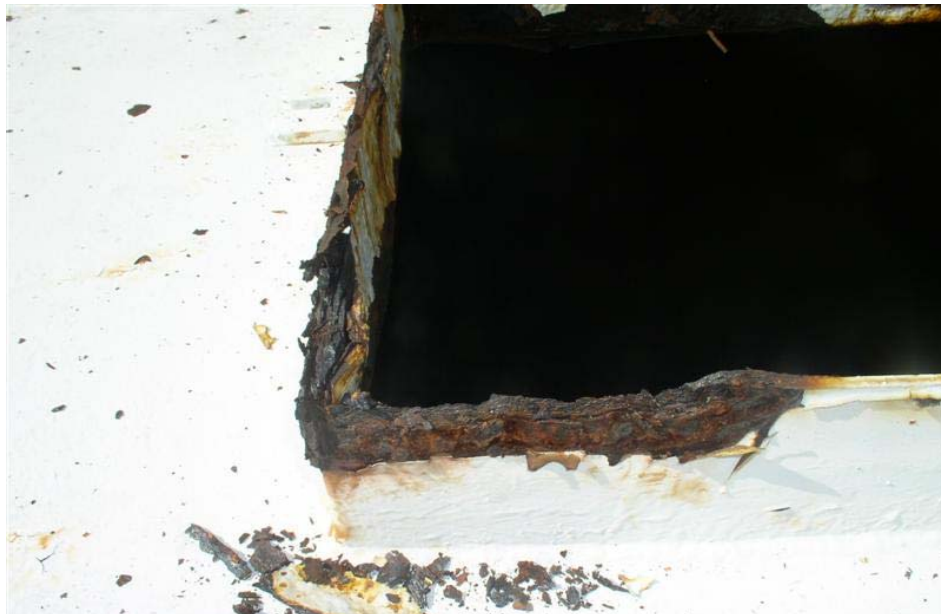
Photo #18 Severe corrosion on roof hatch curb. Recommend to replace curb and hatch cover.

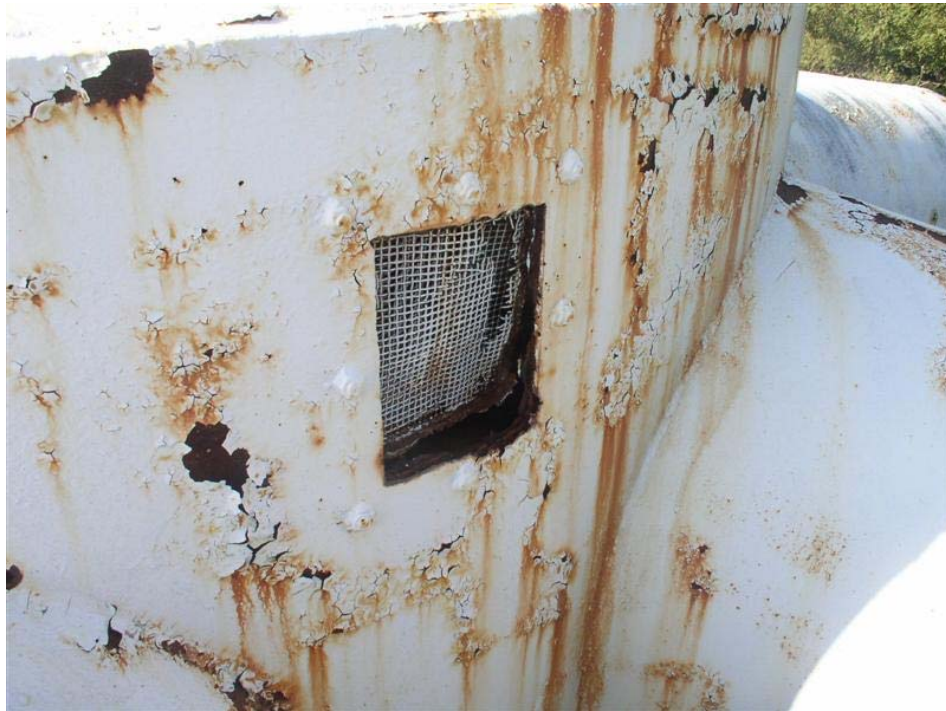
The cupola on the tank roof has vent holes with screens over the holes. When the cupola and pilasters are removed a new 30" or 36" vent will need to be installed. (See photos #19 & 20)

Photo #19 Vent for tank is provided by square holes cut into roof cupola. Screens are damaged allowing birds, insects and other pests to enter the tank and contaminate the finished water.

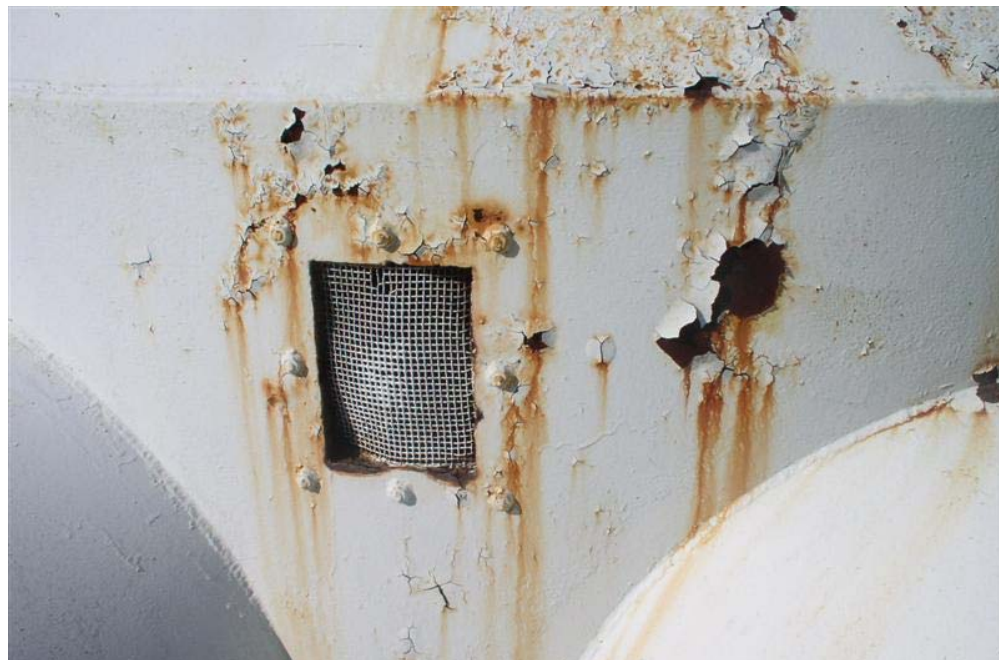
Photo #20 Screen is loose and corroding.

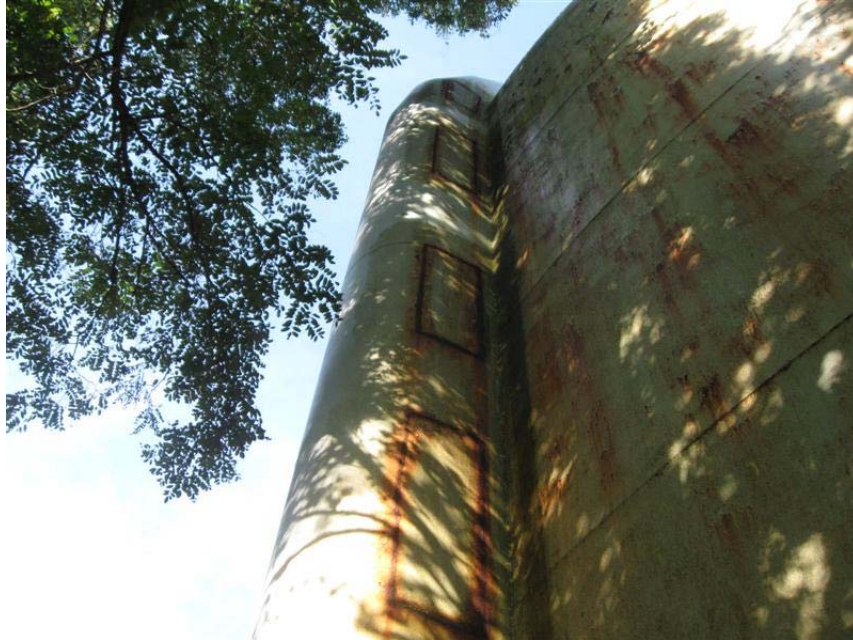
Photo #21 Overflow pipe is likely on the inside of this pilaster and exits underground to the stream on the south side of tank.

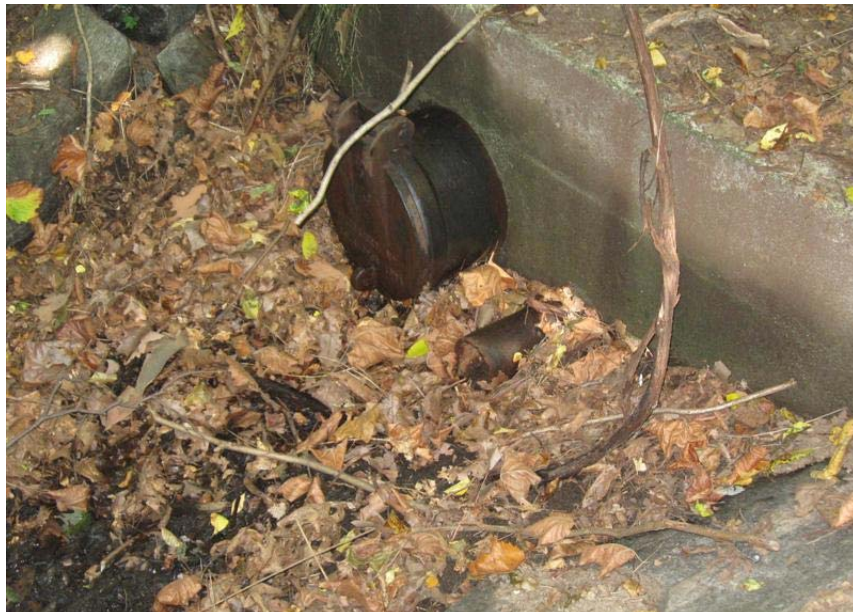
Photo #22 Overflow discharge is properly installed with flapper cover.

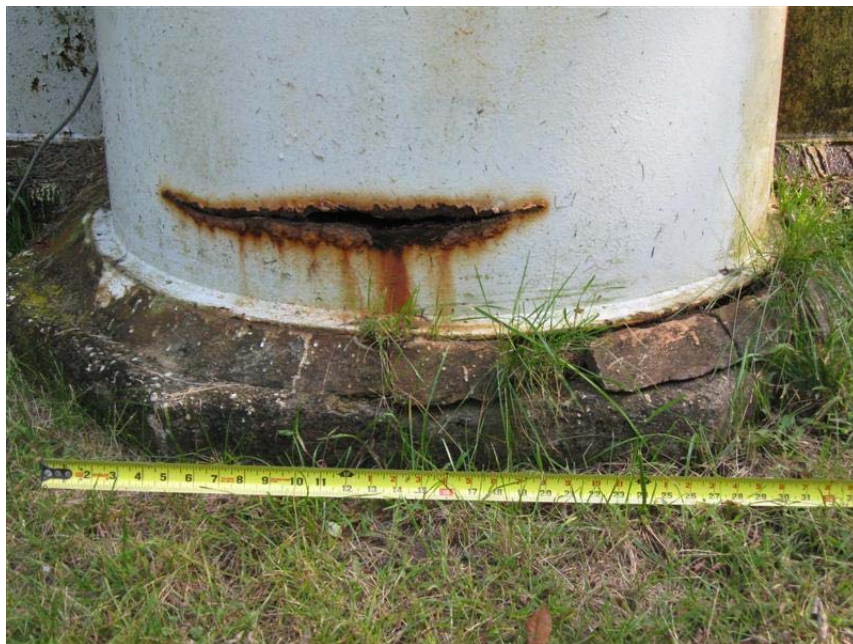
Photo #23 Foundation is in good condition. A layer of mortar was installed around the base to protect the grouting. Mortar ring should be removed and grout repaired. Recommend coating the foundation with epoxy.

It is recommended to repair and/or replace the areas of deteriorating grout and coat the concrete foundation with an appropriate epoxy to protect from freeze/thaw damage.

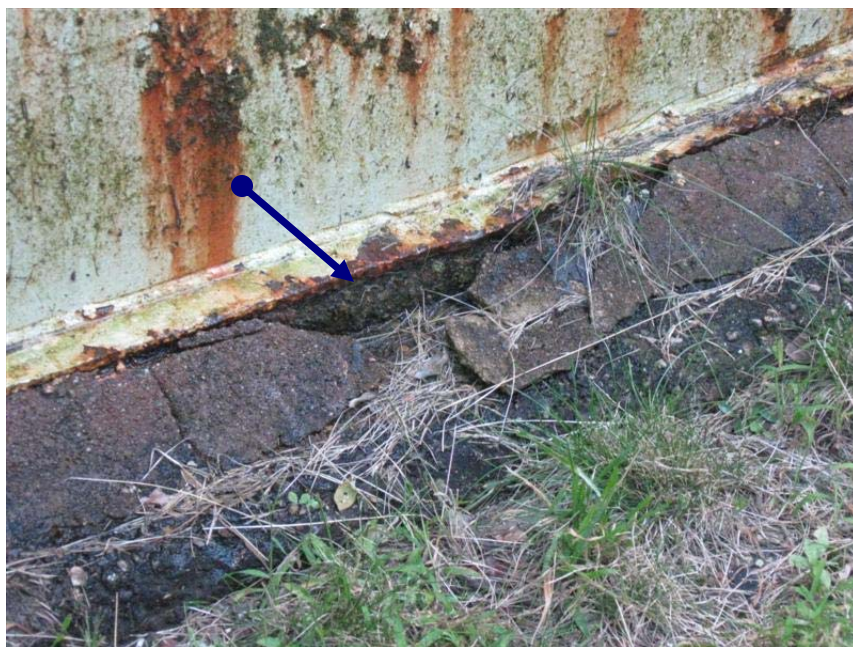
The foundation appears to be in good condition. The grout at the tank base is deteriorating and should be re-grouted during the next renovation. The top of the concrete foundation is not coated as recommended by most standards. (see photo # 24 - 25).

Photo #24 Ringwall foundation is in good condition. Grout appears to be intact (arrow), despite the decay of the mortar ring around tank base.

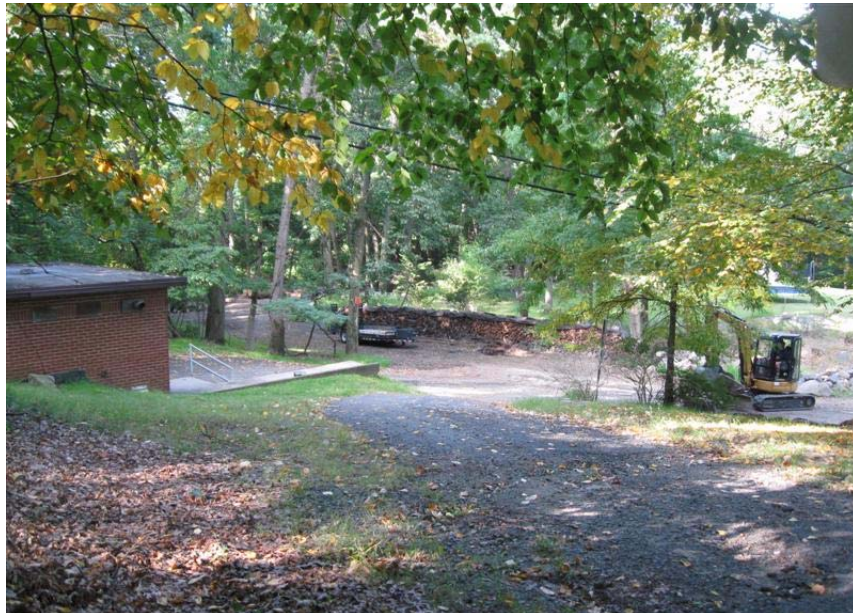
The site has a chain across the driveway to the tank. There is no fencing around the tank. Current US Dept. of Homeland security guidelines suggest that all water tank sites be fenced and "Tampering with this facility is a Federal Offense" signs be posted on and around the site. There are wooded areas near the tank site, but no fencing borders the property to deter intrusion. (See Photos #26 - 28)

Photo #26 Access to site is not very secure. No fencing around site. No security or warning signs are posted at tank site.

Due to the location of the tank, it does not appear to be at significant risk for tampering or vandalism; however we recommend the use of signs to deter intrusion. The site should be fenced and trees that are within 15 feet of the tank should be removed.

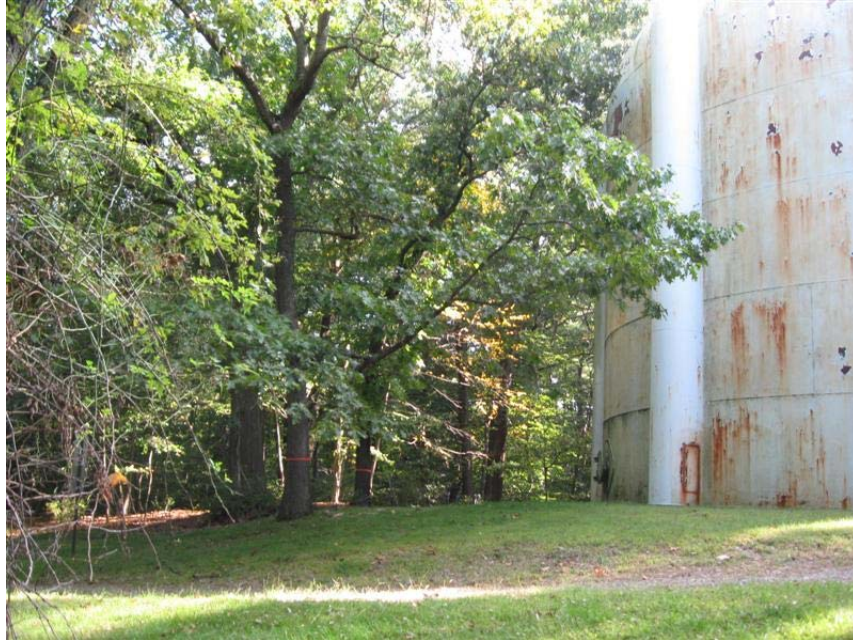
Photo #27 Trees should be removed from perimeter of tank at least 15 feet away.
